THE EFFECT OF ICE COVER ON SEDIMENT TRANSPORT CAPACITY AND STREAM CHANNEL MORPHOLOGY IN A REACH OF CAZENOVIA CREEK, NY

Kelly M. Frothingham
Department of Geography and Planning
Buffalo State College
1300 Elmwood Avenue
Buffalo, NY 14222

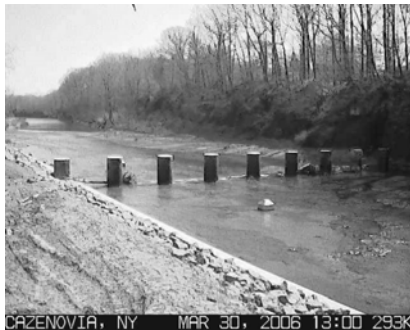
Figure 1. Cazenovia Creek ice-control structure.

The ICS consists of six 1.5 meter diameter cylindrical piers that are 3 meters above the average streambed elevation. The piers are spaced approximately 4 meters apart. The ICS is designed to block an ice jam and allow the ice to accumulate on the floodplain for storage to alleviate downstream flooding.

These frequent ice jams warranted construction of an ice-control structure (ICS) that was built upstream of this study's site during the 2005-2006 winter season (Lever et al., 2000) (Figure 1).

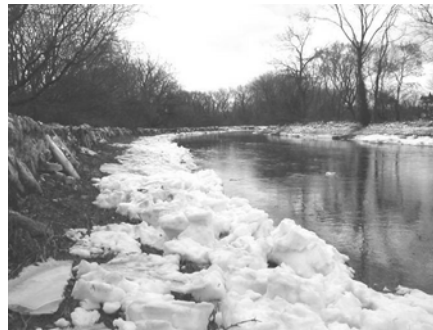
Figure 2. Streambank scour.

Figure 2 shows the USGS gage site after an ice jam breakup in December 2002. That event caused excessive bank erosion where 45-degree streambanks were sheared off by ice slabs to near-vertical banks.

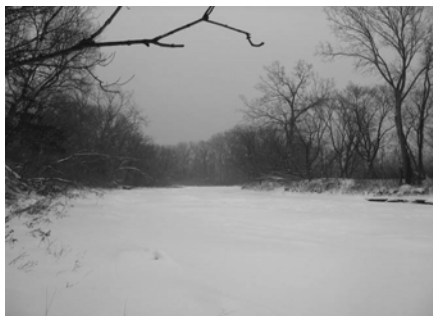
Figure 3. Winter 2005 field work.

Figure 3 shows the gage site with a free-floating ice cover in December 2005. The field team was preparing to collect data on ice thickness and water depth and velocity for a graduate student project associated with the current project.

During the course of this two-year project the Cazenovia Creek site experienced periods of ice cover (Table 1 and Figure 3); however, ice jams did not occur. The thickness of each ice cover was relatively constant (e.g., 3-4 cm thick) across channel cross sections and the ice covers were free-floating. In addition, it was noted that the ice melted gradually (e.g., over a period of days) starting in the center of the channel. Ice on the streambanks melted last, which appeared to protect the banks from erosion, and in some cases, blocks of ice accumulated on the streambanks, which further protected the banks from erosion.

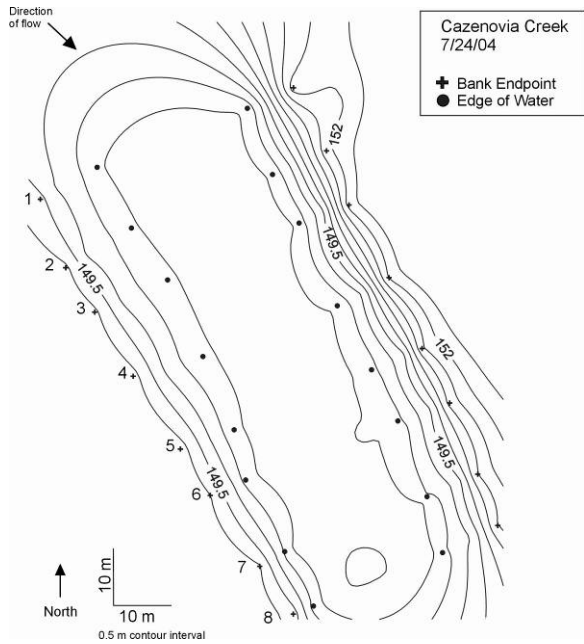
Figure 5. Cazenovia Creek morphology.

The Cazenovia Creek reach was approximately 80 m long and averaged 50 m wide (Figure 5). The reach was relatively straight and uniformly deep with a centrally located thalweg. Reaches in other ice cover studies, both in the field and in lab studies, had similar morphology (e.g., Ettema and Daly, 2004).

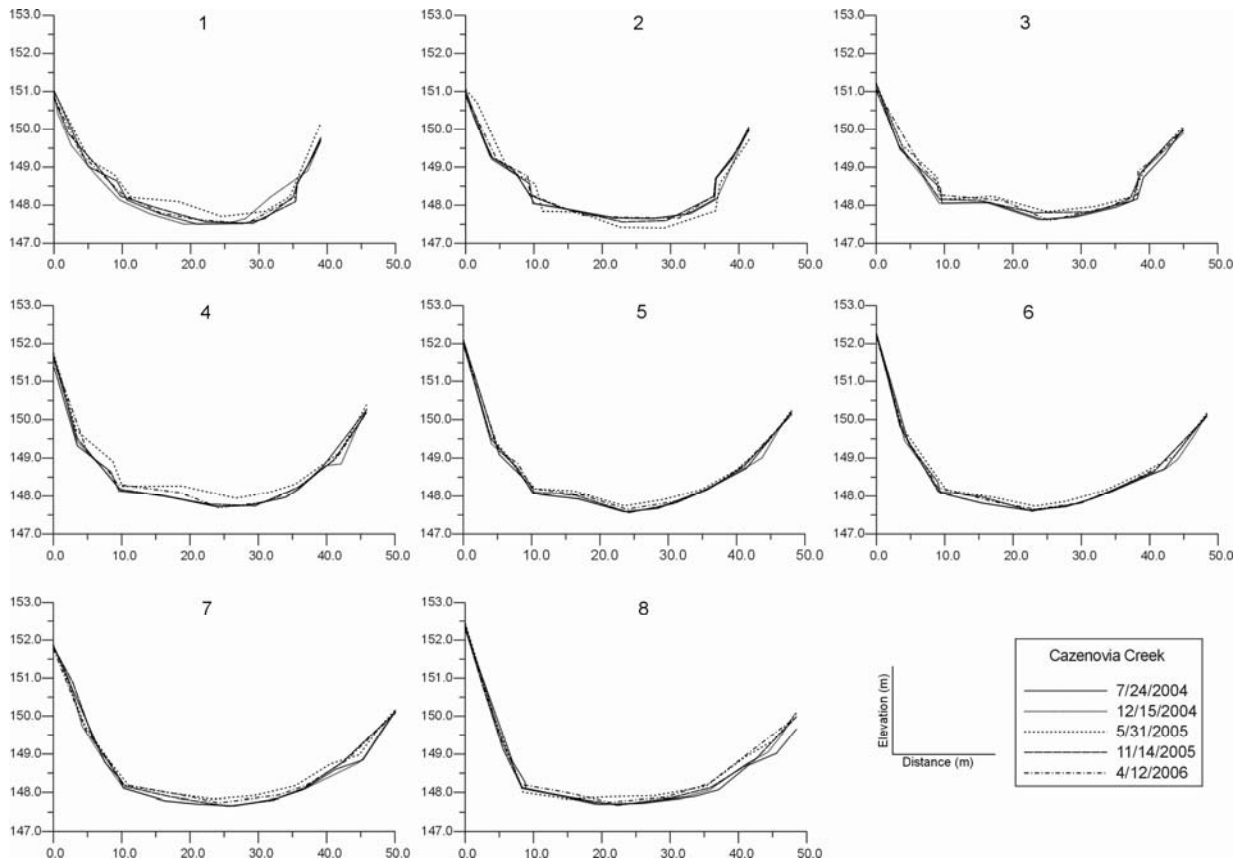
Figure 6. Surveyed cross sections.

Profiles of surveyed cross sections (Figure 6) indicate that overall change throughout the reach

was minimal during the study period. The upstream portion of the reach (cross-sections 1-4) showed greater relative change with as much as 25 cm point elevation change in a cross section. The downstream end of the reach was more stable; for example, less than 5 cm elevation differences along the west bank of cross-section 8.
